# Rapid Bridge Replacement under Emergency Situation: Case Study

Yong Bai, P.E., M.ASCE<sup>1</sup>; William R. Burkett, P.E.<sup>2</sup>; and Phillip T. Nash, P.E.<sup>3</sup>

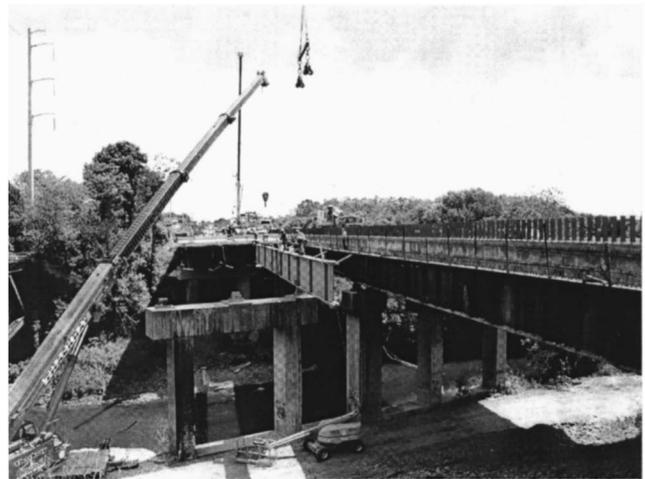
Buckley installed the nine steel girder segments on June 8 and 9. Fig. 2 shows a piece of steel girder being placed on a concrete pier cap. Then, construction crews set 4.3-m-wide (14 ft) steel deck pans between the four rows of girders. Next, reinforcing bars were installed in place for the concrete deck. A total of 38 truckloads of concrete were placed to form the new 254 mm (10 in.) deck on Tuesday, June 16. Fig. 3 presents the new concrete bridge deck. While the concrete cured, construction crews poured new parapet walls on the bridge. The compressive strength of the concrete deck exceeded the required 27,560 kilopascals (4,000 psi) less than a week after the deck pour. On June 25,

Fig. 2. Placing steel girder on concrete pier cap

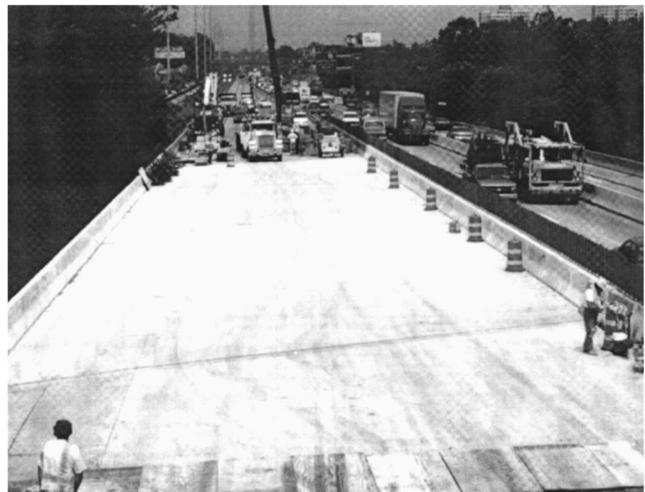
Fig. 3. New concrete deck
