# CORROSION RESISTANCE OF STAINLESS STEEL CLAD REINFORCING BARS

A Report on Research Sponsored by  
Commercial Metals Company

Structural Engineering and Engineering Materials  
SL Report 19-3  
September 2019

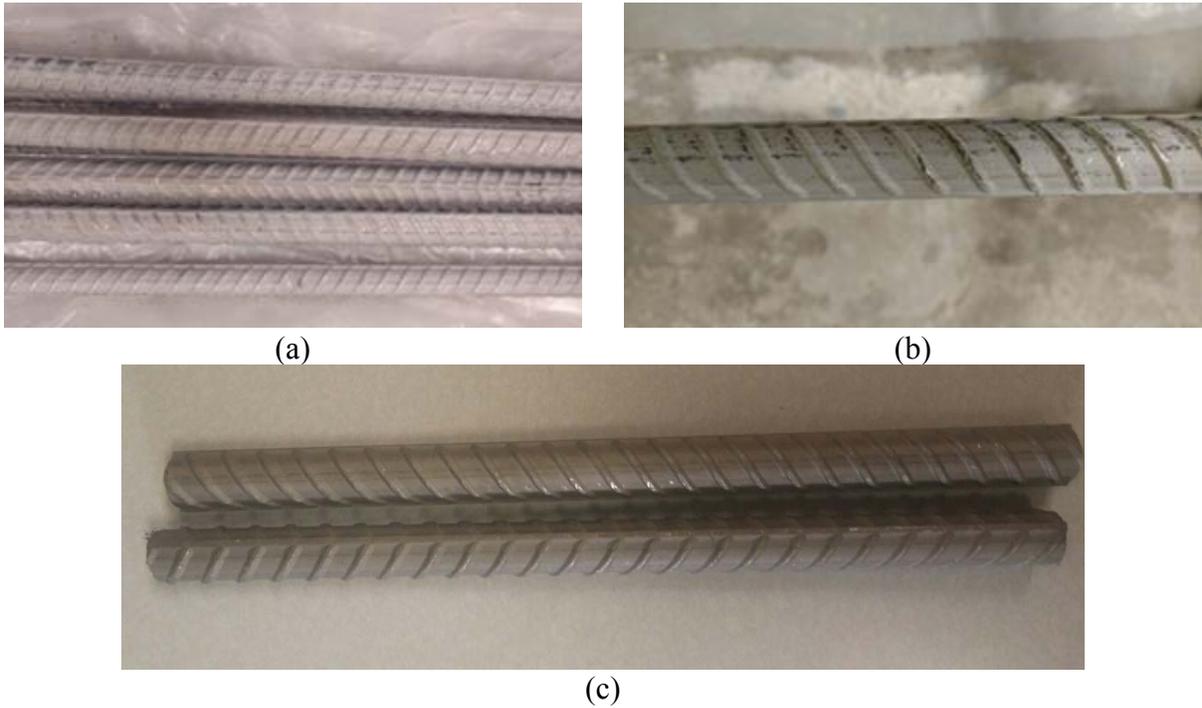
**Figure 1:** Test bars a) As-received condition, b) Close up of residue on bars, c) Bars after cleaning and repickling

The bars were hot-rolled carbon steel encased in a bonded Type 316 stainless steel shell. The stainless steel was pickled in a 20% hydrochloric acid solution for 5 minutes prior to shipment. Upon receiving the reinforcing bars, it was noted that a dark-colored residue was present on a portion of the bar surface (Figures 1a and 1b). The bars showed no surface rust (Figure 1a). To determine if the residue affected the corrosion performance of the steel, the bars were tested in the rapid macrocell test both in the as-received condition and after sandblasting and repickling the surface in a mixture of 25% nitric acid and 5% hydrofluoric acid at 73 °F for five minutes to remove the residue. Figures 1b and 1c show the surface of the bars before and after cleaning, respectively. The testing program is summarized in Table 1.

The residue on the surface of the bars posed some concern, as prior tests on multiple alloys of stainless steel have indicated stainless steel performs poorly when the surface finish is uneven (Darwin et al. 2013, O'Reilly et al. 2017). In this case, no such detrimental behavior was observed. The source of the residue, however, should still be identified and eliminated if possible.

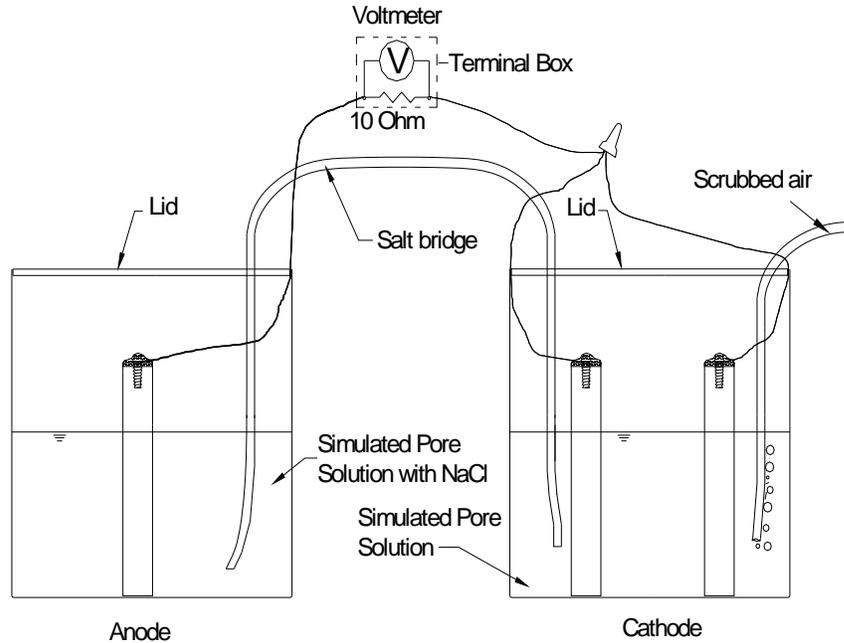
**Figure 2:** Schematic of rapid macrocell test

The rapid macrocell test exposes bars to simulated concrete pore solution with and without chloride contamination and is outlined in Annex A2 of ASTM A955/A955M-16a. A schematic of the test is shown in Figure 2. A single rapid macrocell specimen consists of an anode and a cathode. The cathode consists of two bars submerged to a depth of 3 in. in simulated concrete pore solution in a plastic container, as shown in Figure 2. One liter of pore solution consists of 974.8 g of distilled water, 18.81 g of potassium hydroxide (KOH), and 17.87 g of sodium hydroxide (NaOH). Air is bubbled into the cathode solution to remove carbon dioxide and provide oxygen required for the cathodic reaction. The anode consists of a single bar submerged in a solution consisting of the simulated pore solution and 15 percent sodium chloride (NaCl), prepared by adding 172.1 g of NaCl to one liter of pore solution. The solutions are changed every five weeks to limit the effects of carbonation. The anode and cathode are connected electrically across a 10-ohm resistor.

A potassium chloride (KCl) salt bridge provides an ionic connection between the anode and the cathode (Figure 2). Deionized water is added to maintain the desired solution depth.

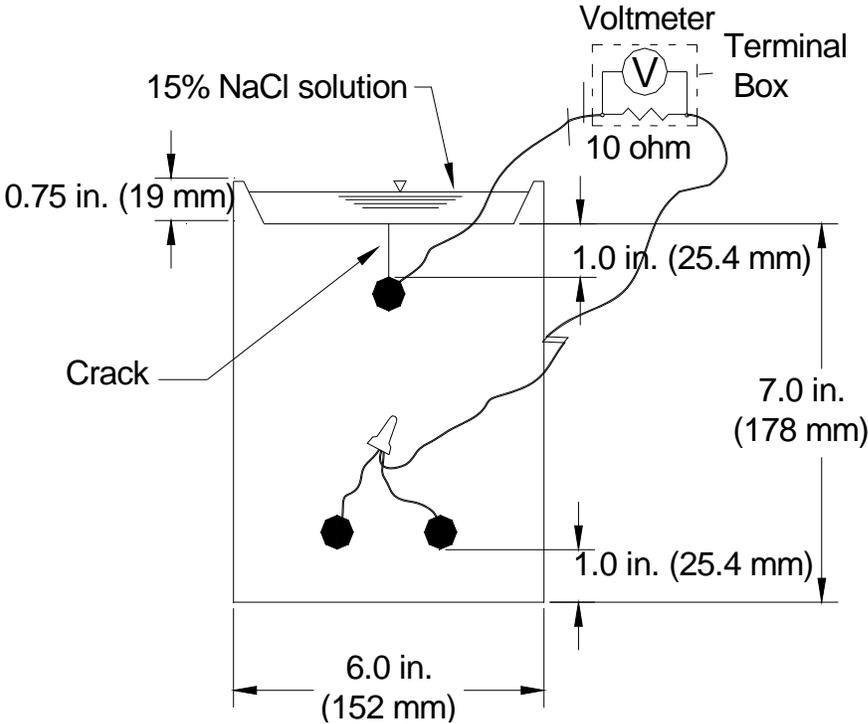
**Figure 3:** Schematic of cracked beam (CB) specimen

In the cracked beam (CB) test, specimens containing reinforcing steel are subjected to cyclic ponding and drying with a 15% sodium chloride (NaCl) solution. Cracked beam specimens (Figure 3) measure 12 × 6 × 7 in. These specimens contain two mats of steel. The top mat consists of a single No. 6 bar; the bottom mat consists of two No. 6 bars. This test simulates exposure conditions in cracked concrete. The specimens are cast in an inverted position. Prior to casting, a 12-mil thick × 6-in. long stainless steel shim is affixed in the mold in direct contact with the top reinforcing bar, producing a simulated crack that allows for direct infiltration of chlorides at the beginning of the test. The shim is removed about 12 hours after casting.

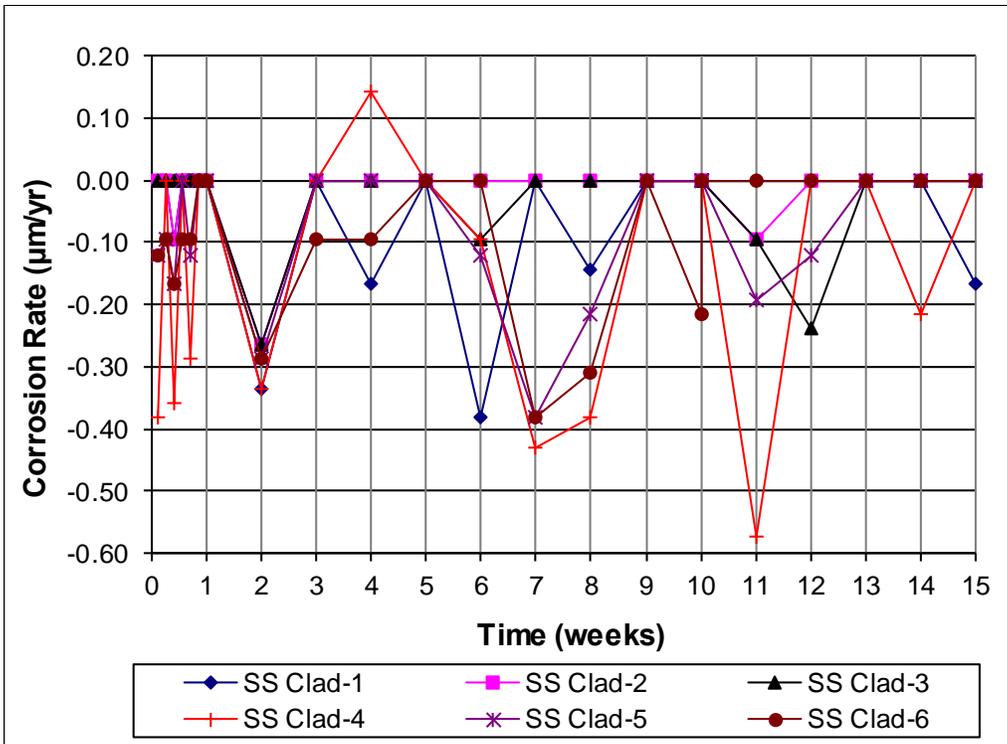
**Figure 4:** Corrosion rate for as-received specimens

Figures 4 and 5 show the individual corrosion rates for the as-received and repickled specimens, respectively. Figure 6 shows the average corrosion rate for the specimens. Through 15 weeks, the maximum individual corrosion rates for the as-received and repickled specimens were 0.174 and 0  $\mu\text{m}/\text{yr}$ , respectively; the average corrosion rate was 0 for both series of tests (Negative corrosion rate values are artifacts of the test method and are not indicative of “negative” corrosion). Both series of specimens met the requirements of ASTM A955. The residue observed on the stainless steel clad bars did not have a significant impact on the corrosion resistance of the bars.

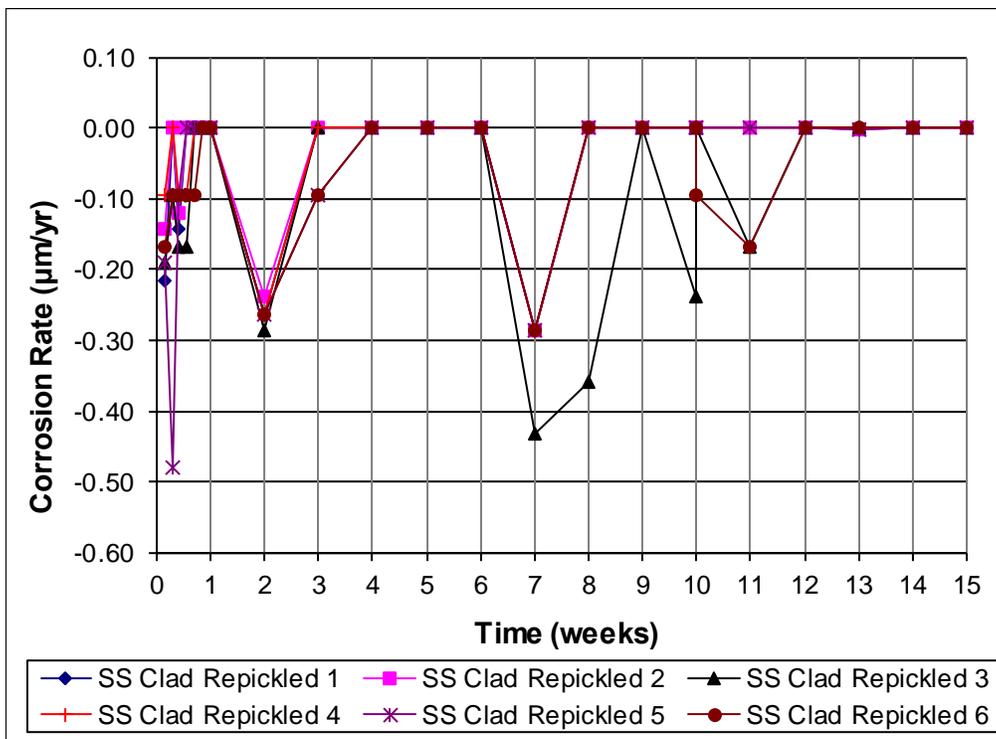
**Figure 5:** Corrosion rate for repickled specimens

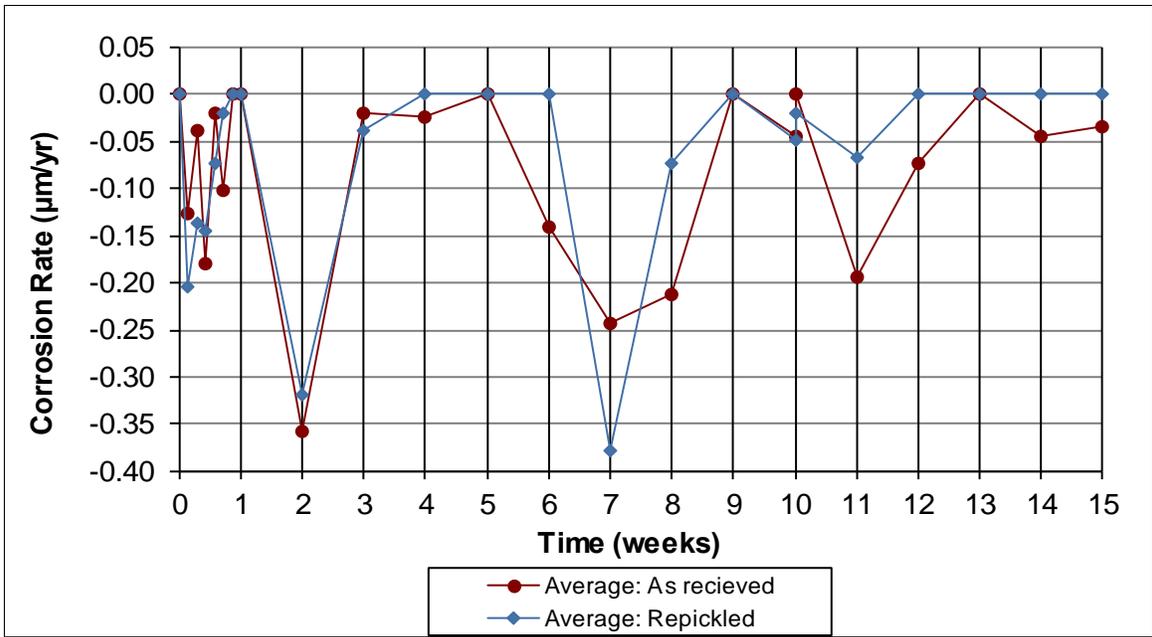
**Figure 6:** Average corrosion rate for as-received and repickled specimens

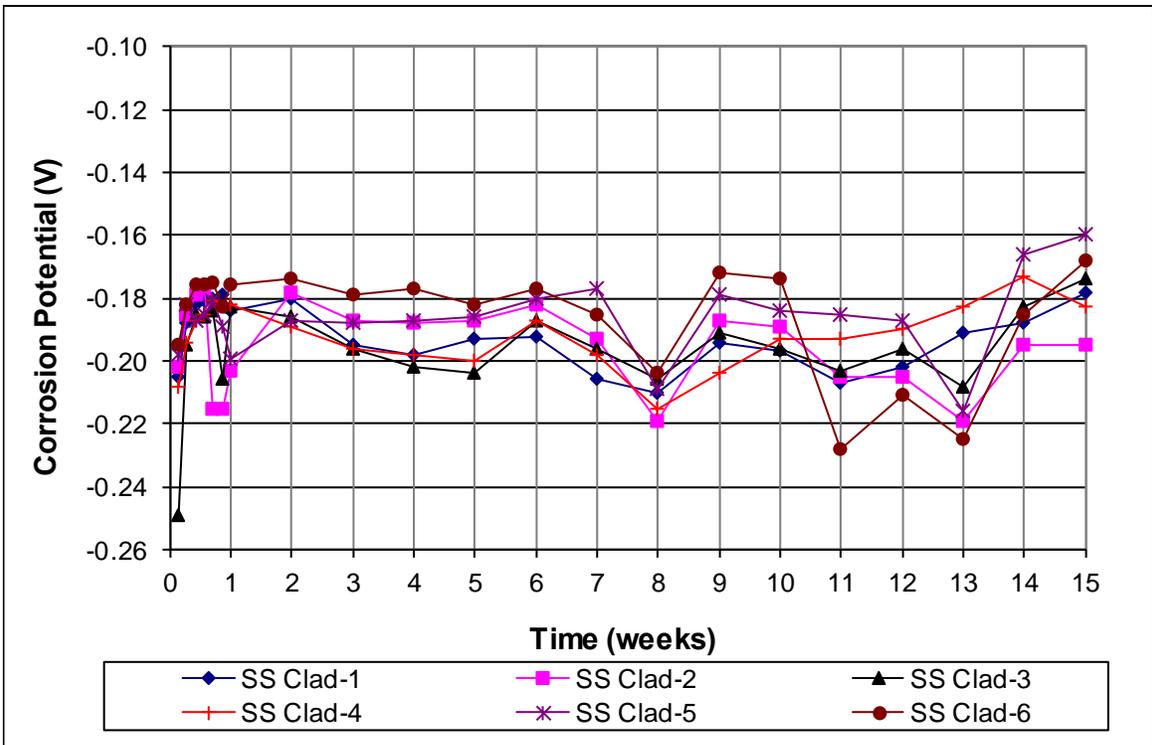
**Figure 7:** Corrosion potential for as-received specimens with respect to CSE.

Figures 7 and 8 show the corrosion potentials of the as-received and repickled specimens, respectively. Figure 9 compares the average corrosion potentials for the two types of specimens. The potentials remained around  $-0.20\text{ V}$  for bars in both the as-received and repickled conditions, indicating little corrosion activity.

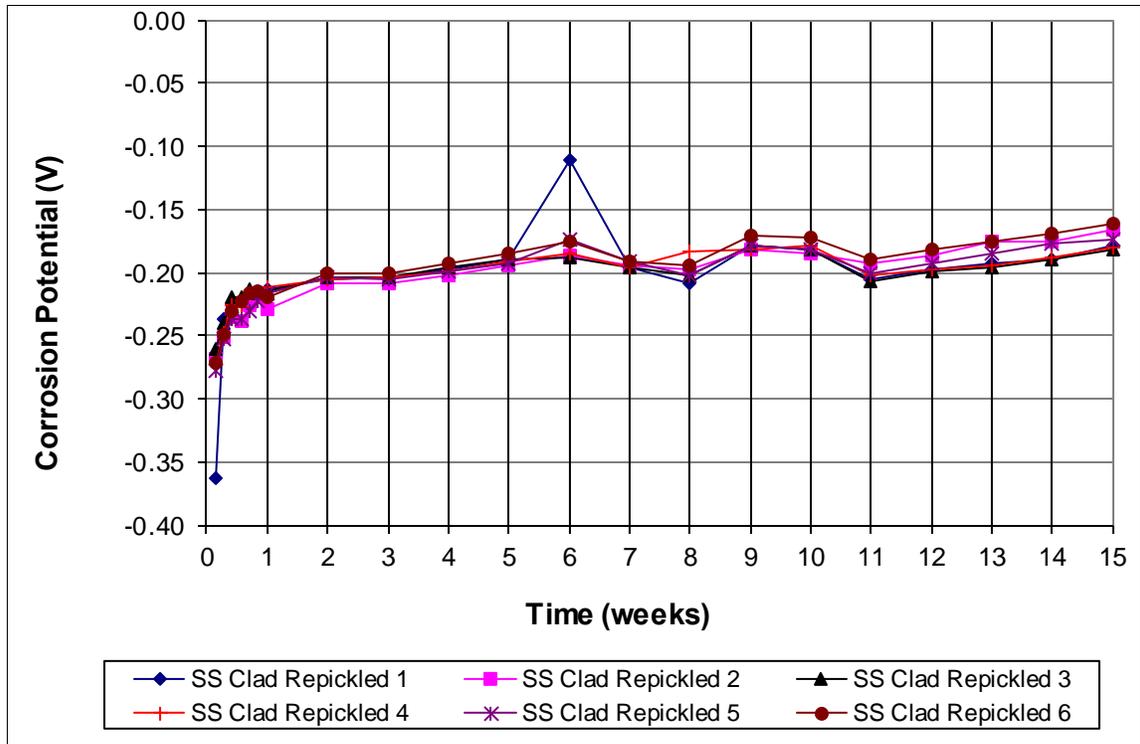
**Figure 8:** Corrosion potential for repickled specimens with respect to CSE

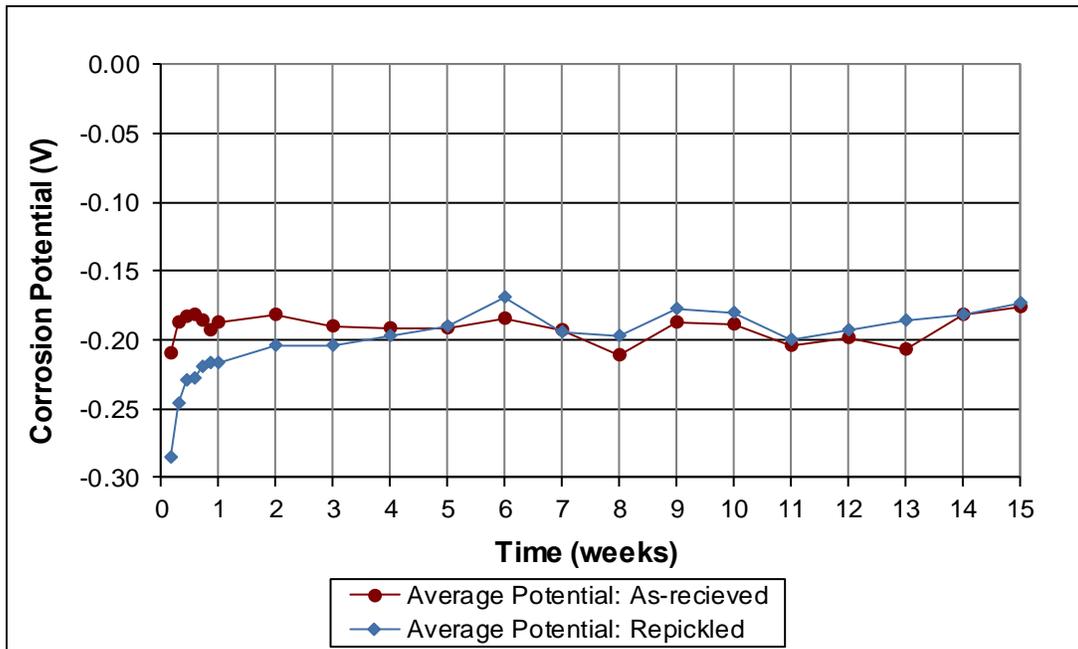
**Figure 9:** Average corrosion potential for as-received and repickled specimens with respect to CSE

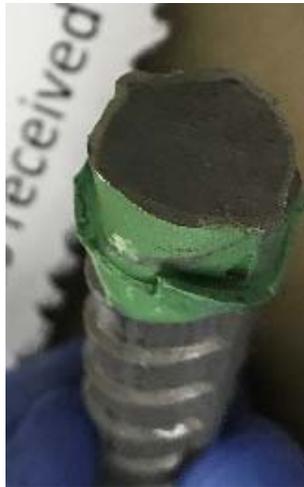
**Figure 10:** Specimen SSClad-1 (as received), anode bar (a) after testing, (b) with end cap removed.

After testing, the surface of the bars were examined for corrosion, and the end caps removed to inspect for corrosion at the cut ends of the bar. Figure 10 shows specimen SSClad-1

after testing (Figure 10a) and with the end cap removed (Figure 10b). No signs of corrosion were observed on any of the bars.

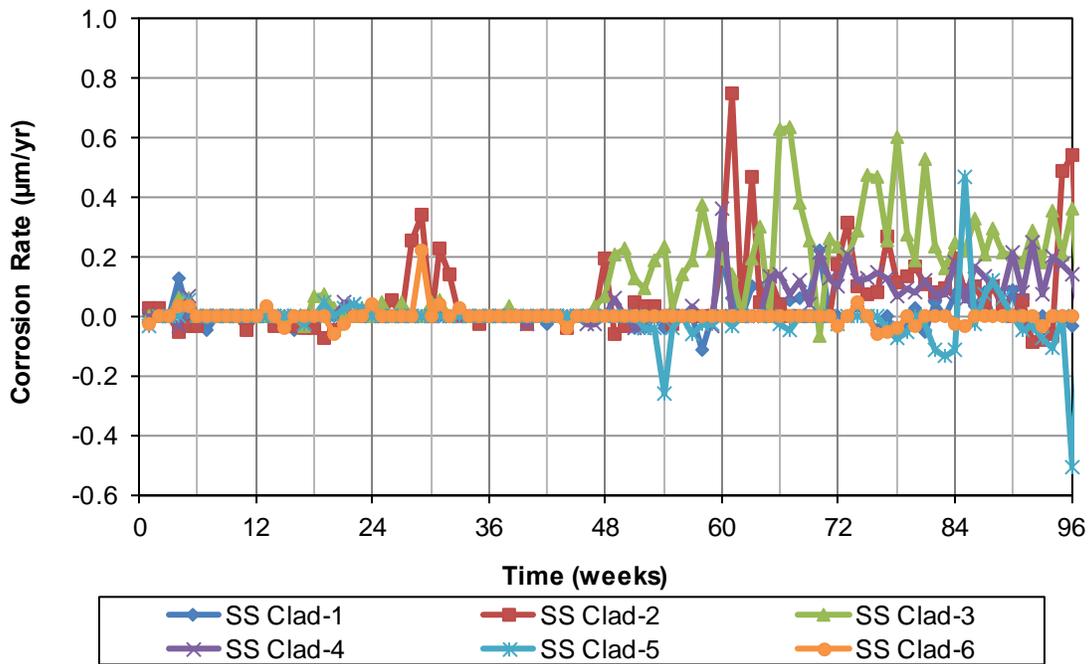
**Figure 11:** Corrosion rate for cracked beam specimens

Figures 11 and 12 show the individual and average corrosion rates for the stainless steel clad bars in the cracked beam test. Figure 13 shows the individual top mat corrosion potentials with respect to a copper sulfate electrode (CSE). The corrosion rate of two specimens, SS Clad-2 and SS Clad-3, exceeded the maximum of value of  $0.50 \mu\text{m}/\text{yr}$  permitted by ASTM A955. As explained below, however, these specimens are considered to have satisfied this test requirement.

The average corrosion rates of all six specimens remained below the maximum of 0.20  $\mu\text{m}/\text{yr}$  permitted by ASTM A955. Through 96 weeks, the maximum individual corrosion rate for the specimens was 0.75  $\mu\text{m}/\text{yr}$  (specimen SS Clad-2 at week 61). This specimen experienced a corrosion rate greater than 0.50 again at week 96 when it reached a corrosion rate of 0.541  $\mu\text{m}/\text{yr}$ . Specimen SS Clad-3 exhibited a corrosion rate above 0.5  $\mu\text{m}/\text{yr}$  at weeks 66, 67, 78, and 81. Specimen SS Clad-3 is the only specimen to have shown corrosion rates greater than 0.50  $\mu\text{m}/\text{yr}$  for two consecutive weeks. These spikes in corrosion rate correspond to drops in corrosion potential on the specimens (Figure 13). The maximum average corrosion rate was 0.162  $\mu\text{m}/\text{yr}$  at week 60.

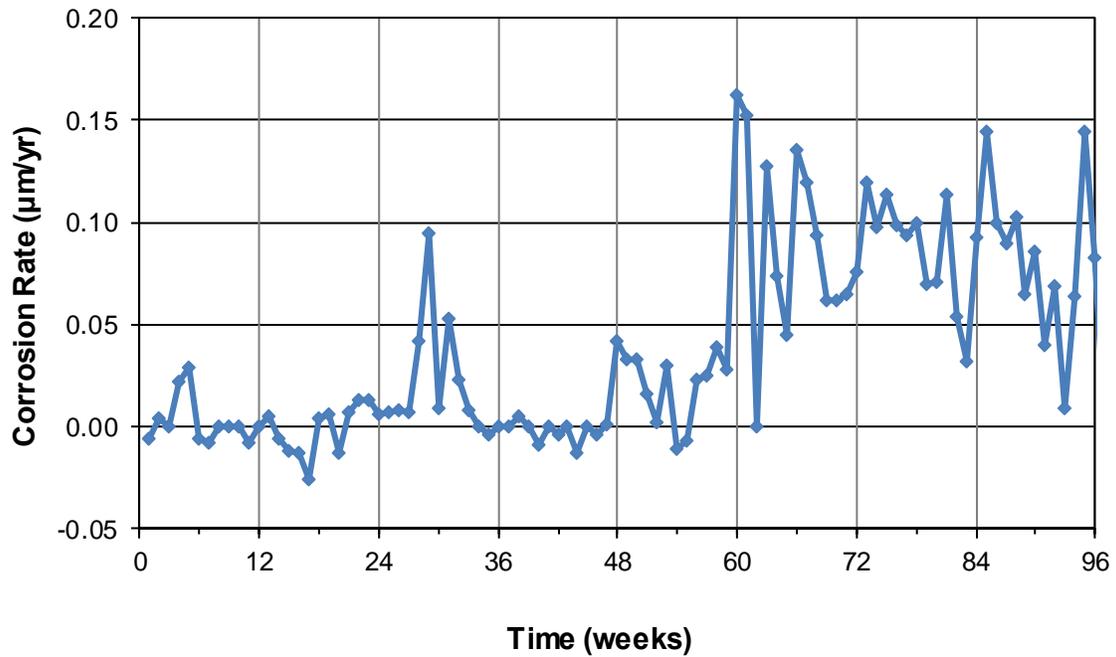
**Figure 12:** Average corrosion rate for cracked beam specimens

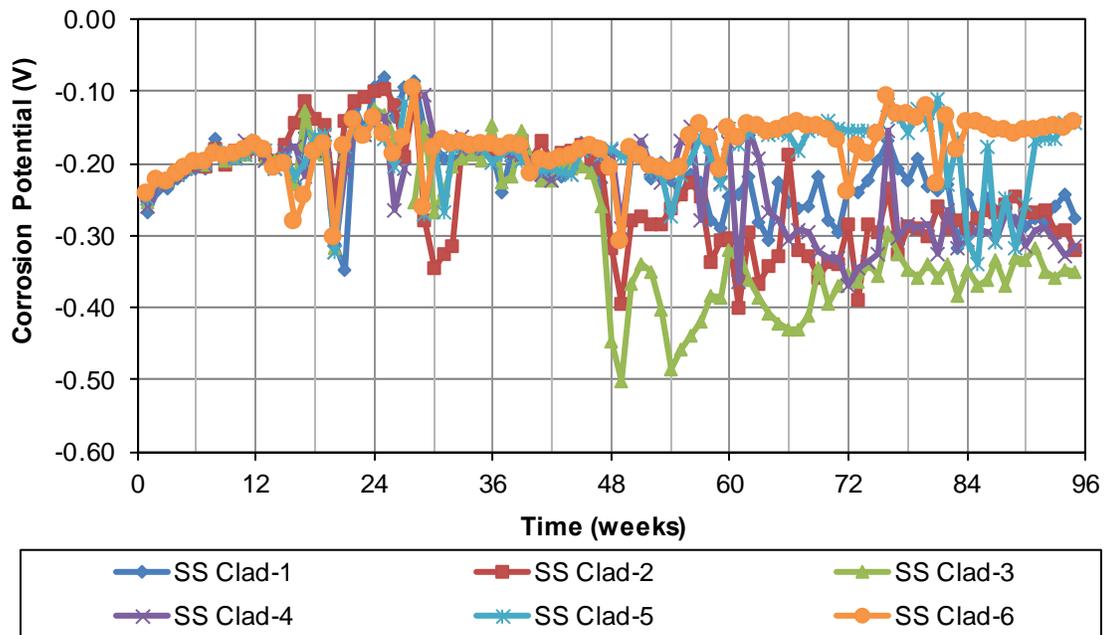
**Figure 13:** Top mat corrosion potential with respect to CSE for cracked beam specimens

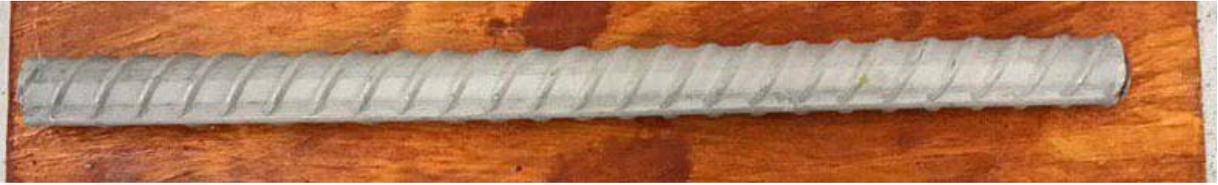
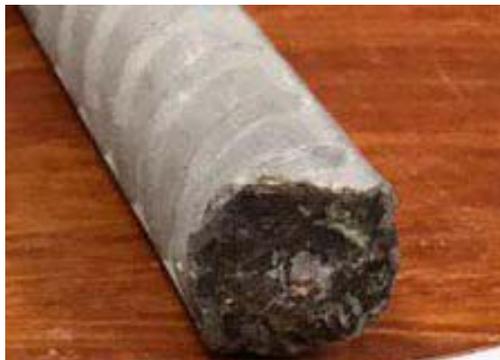
**Figure 14:** Stainless steel clad bars after testing, (a) SSClad-2, top bar, (b) SSClad-3, top bar, (c) cut end of SSClad-2

After testing, the specimens were autopsied to determine if corrosion was occurring on the cladding or at the cut end of the bars. Figure 14 shows top bars after they were removed from the

concrete blocks at week 96. Neither SS Clad-2 nor SS Clad-3, the two specimens that exhibited the high corrosion rates during the test, showed any signs of corrosion on the clad regions of the bars (Figures 14a and 14b). Corrosion, however, was visible on the cut end of the bars (Figure 14c). A number of the other bars also exhibited corrosion at this location, explaining the positive rates seen on several specimens in the cracked beam test (Figure 11).

The difference in behavior of the stainless steel clad bars between the rapid macrocell and cracked beam tests can be attributed to the end condition of the bars. In the rapid macrocell test,

the cut ends of the bars are well-protected by a vinyl cap and two layers of epoxy. With the ends well protected, the bars exhibited low or no corrosion activity over the duration of the test. In the cracked beam test, the cut ends are not as well protected, and chlorides were able to reach the conventional steel core of the bars and initiate corrosion. The high corrosion rates observed in the cracked beam specimens should not be attributed to a failure of the cladding, but rather to the need to protect the cut ends of the bars with a durable cap when using them in the field. With protection, the bars are considered to have satisfied the requirements of Annex A of ASTM A955.
